CALIFORNIA PAVEMENT FAULTING STUDY

INTERIM REPORT

MATERIALS AND RESEARCH DEPARTMENT
RESEARCH REPORT
NO. M & R 635167-1

Prepared in Cooperation with the U.S. Department of Transportation, Bureau of Public Roads January, 1970

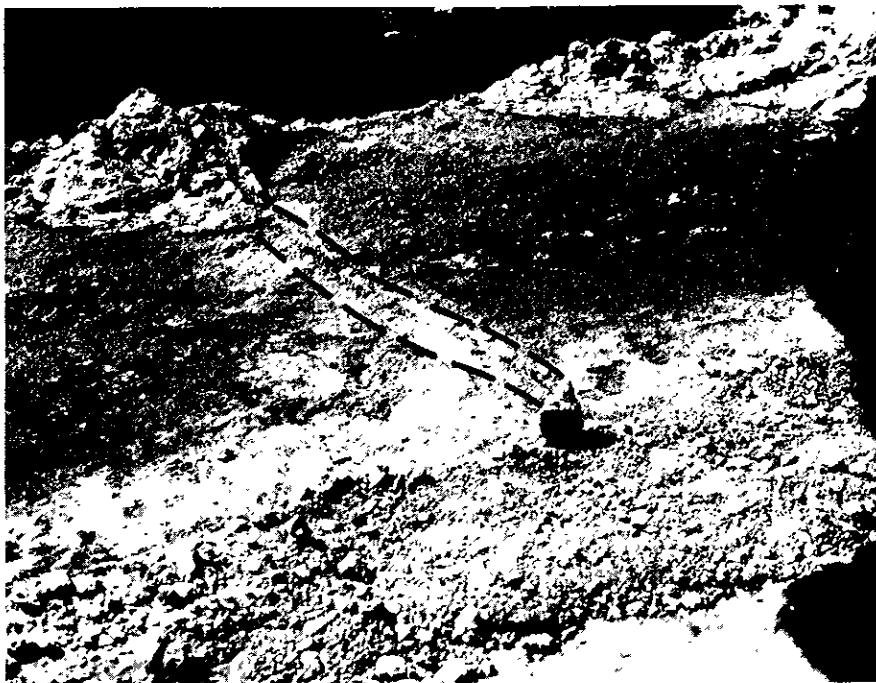
This site was on the inside, or No. 1 lane, and at the same joint as 2A. Pavement thickness in this lane is 0.67-ft. The purpose of the opening was to compare the unfaulted portion of the joint with the faulted. Figure 5 shows the condition of the CTB under the slab. A ridge of concrete and sandy particles was found under the joint, but there was no other sign of any buildup or movement of material. A tight crack was found in the CTB near the joint in this lane also.

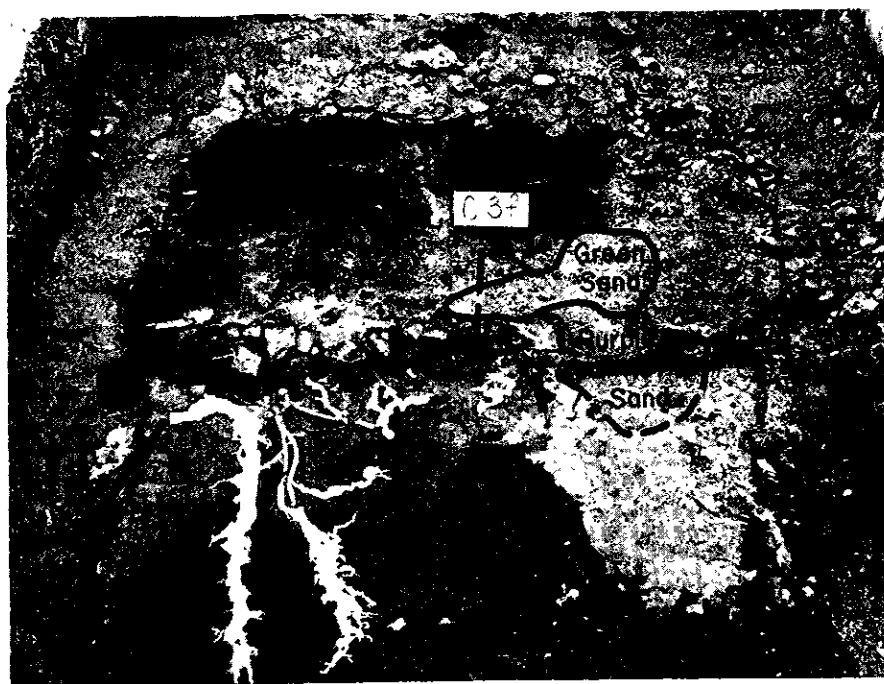
Figure 12

At the 0.30-inch faulted joint, the melted paraffin followed distinct channels under the leave slab (see Figure

12). The buildup under both slabs appeared to be quite thick and similar to that at Location 1. As was the case at Pismo Beach, however, the original surface plane of the CTB could not be definitely identified. Some of the pink sand placed in the shoulder had moved a few inches under the pavement, and again, mostly under the leave slab. The green sand from the approach slab was somewhat scattered with the greatest movement being toward the shoulder. The purple sand from the leave slab was almost entirely displaced to the approach portion. Some particles were found on the approach side as much as three feet from the joint. The position of these sands strongly suggests some circular motion of the water. There was also a tight, but unfaulted, crack in the CTB at this site.

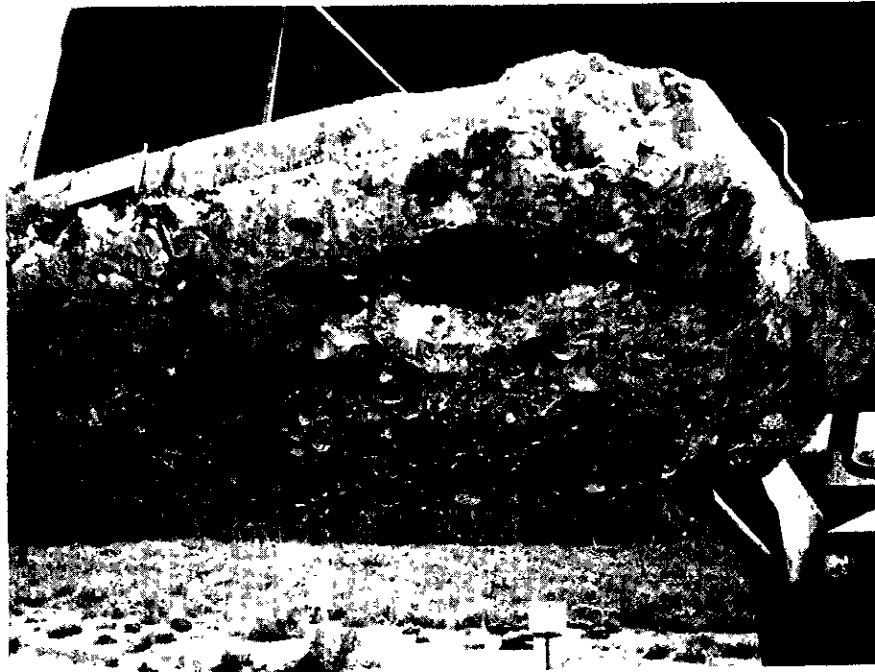
Figure 14

When the slab was lifted at the unfaulted joint, the CTB broke loose around the edges and remained bonded to the PCC (see Figure 14). Since the CTB at this opening had not been isolated by the pavement breaker, considerable bond strength had to exist. No measurement of the bond was obtained however. The asphalt curing membrane, where visible, was still in a plastic or tacky condition.

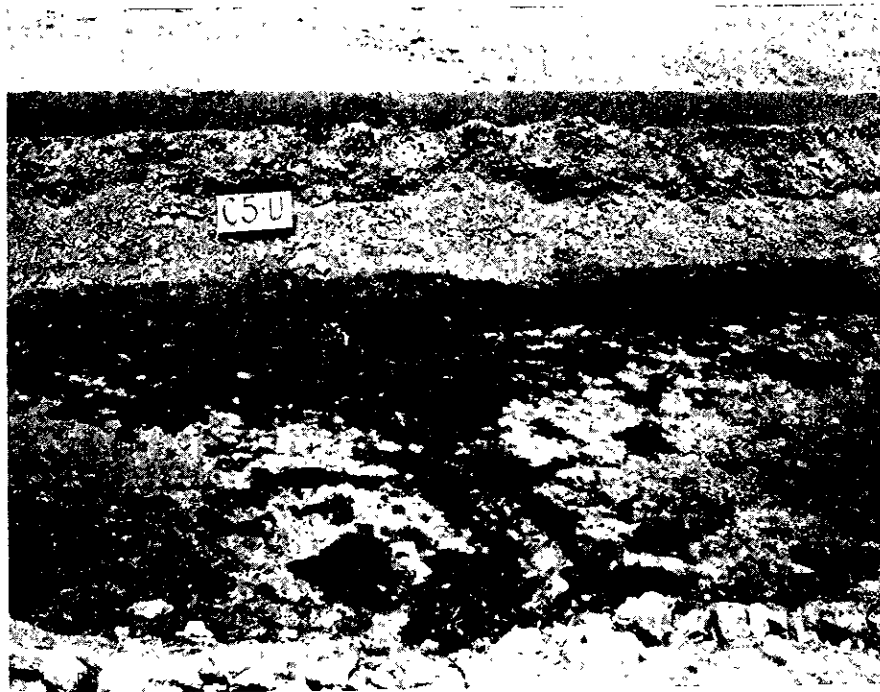
Figure 15

At the unfaulted joint there was no apparent buildup (see Figure 15), and the tracer sands had not moved. In fact, most of the tracer sand adhered to the sides of the core hole and was removed with the slab. The CTB was so weak that cores could not be taken.

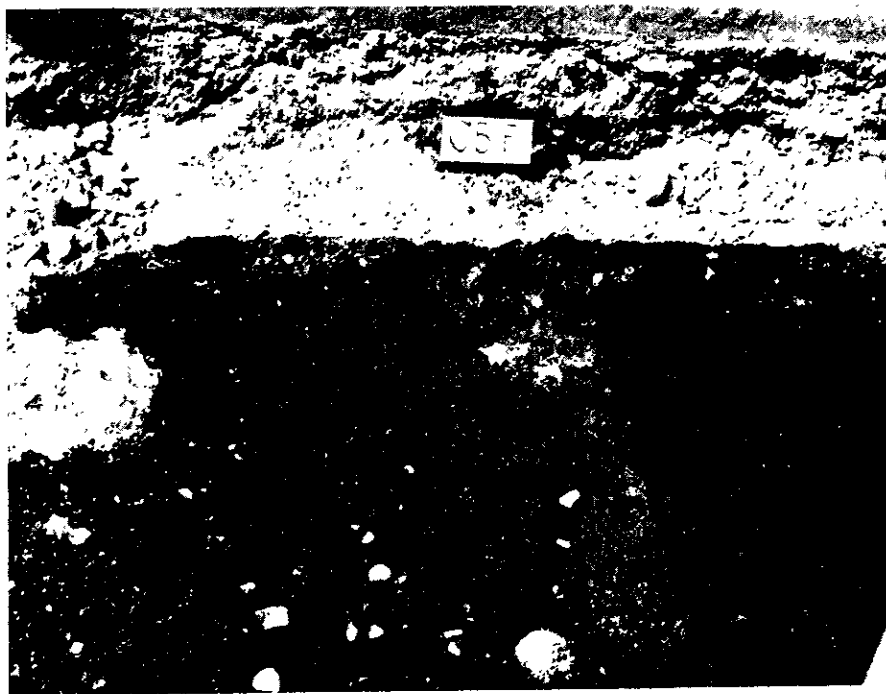
Figure 16

While there was some buildup at the faulted joint (Figure 16), the surface plane of the CTB was difficult to identify. As seen in Figure 17, the CTB was so cohesionless it could be removed with a shovel. No movement of the tracer sands had taken place.
